Villages in Langtang Valley destroyed by
landslides and pressure waves during the 25
April 2015 earthquake

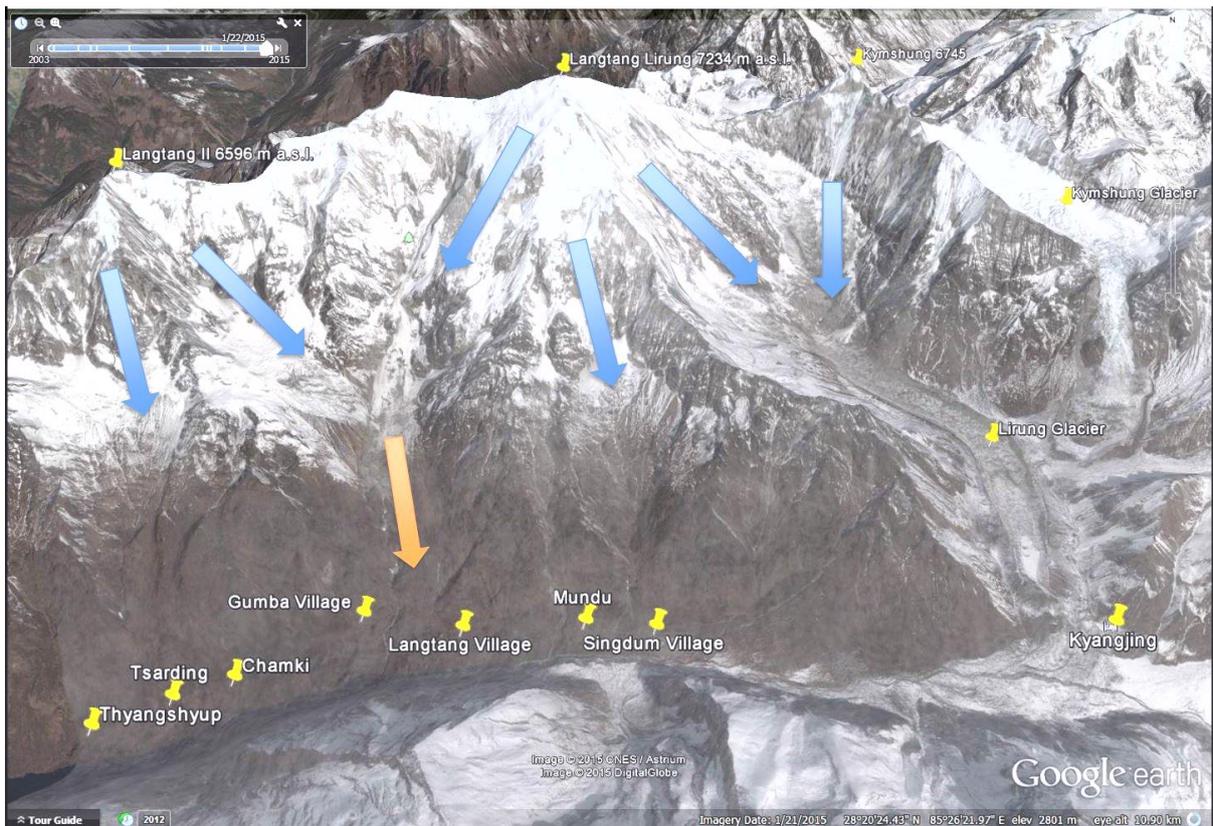
Figure 1: The eight highest villages of Langtang Valley with the source areas of the avalanches (blue arrows) and the main landslide material (orange arrow) covering Langtang village.

As a result, the valley's eight highest villages were damaged or completely destroyed, and many lives were lost. Four of these villages, Tsarding, Chamki, Gumba, and a large part of Langtang – the main village of the valley – were also covered by a long runout landslide, which damaged these villages beyond recognition. The newer, western part of Langtang village is covered by a mass of debris and ice. The foundations of the houses in the older, eastern part of Langtang village are still clearly visible in a photograph taken after the event, and suggest that this part of the village was affected by the pressure wave, but not covered by the landslide (Figure 2). Only two buildings in Langtang were not damaged beyond recognition: the new health post above the village, and a house built very close to a high rock wall in the north of the village.

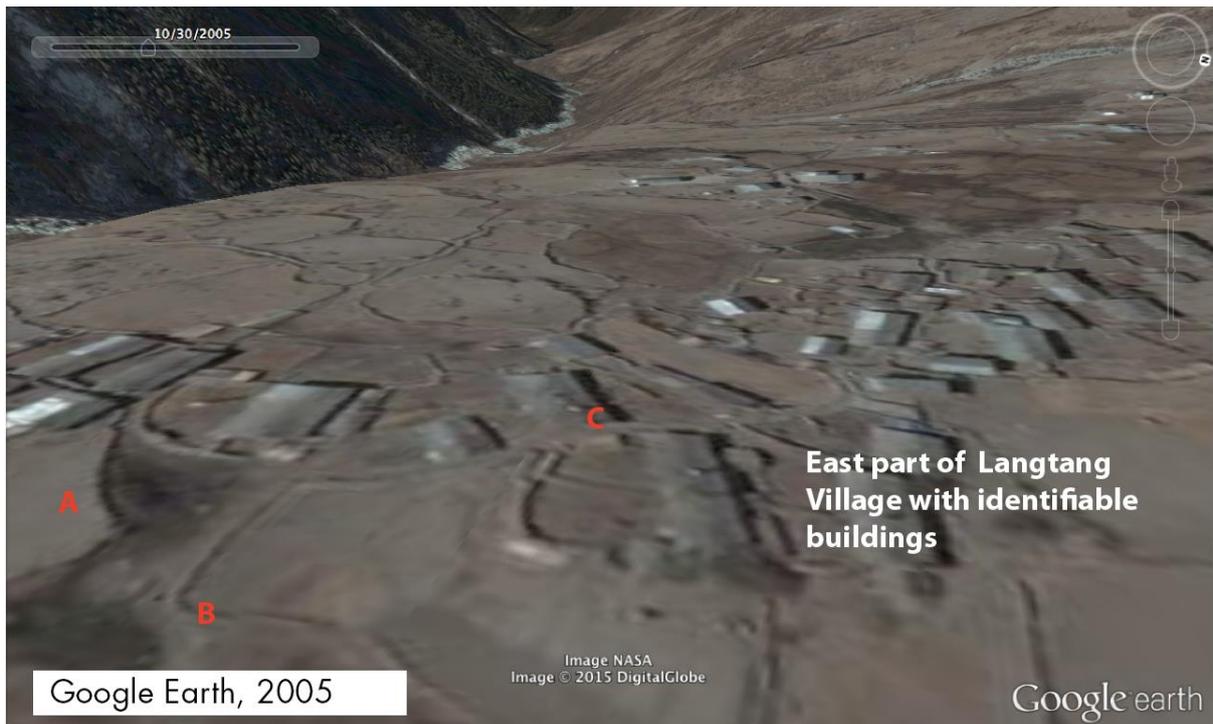
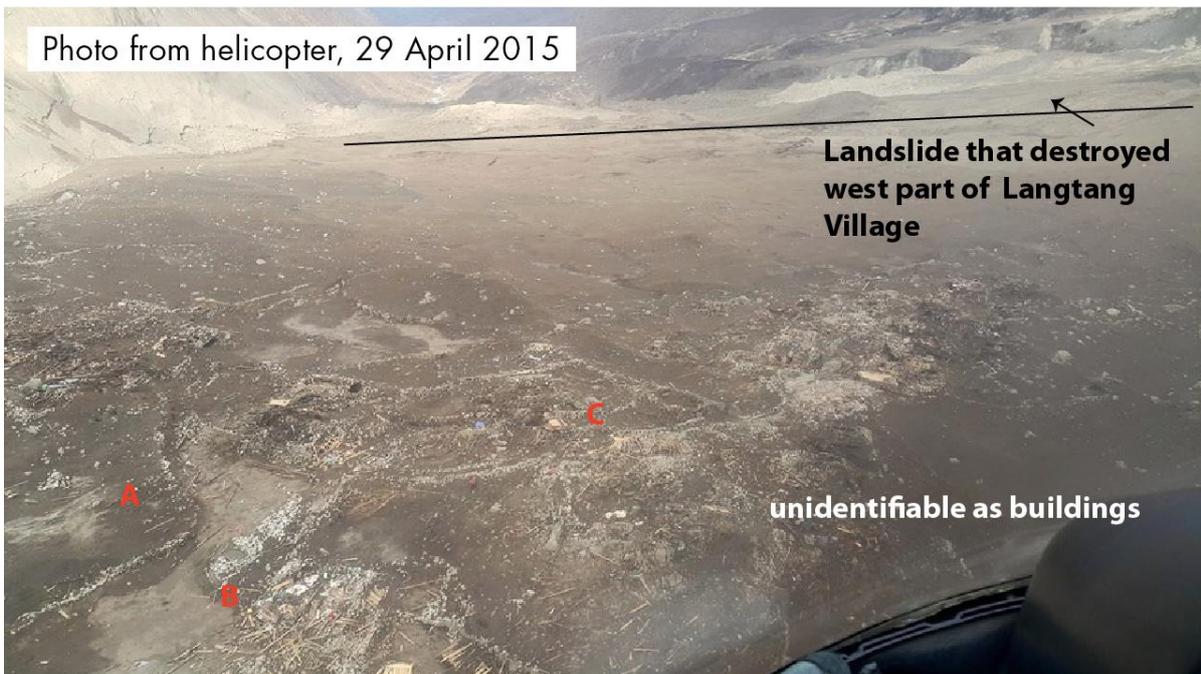
Figure 2: The old, eastern part of Langtang Village is shown in a Google Earth image from 2005 (top) and a photo taken from a helicopter (bottom, credit: Ang Norbu Sherpa, Facebook, 29 April 2015). In the foreground of the bottom figure, the foundations of the houses can still be recognized, whereas a rockslide covers the newer, western part of Langtang Village in the background. Fine debris particles cover most of the area. Source: Thomas H. Painter
