HYDROSAR – WEATHER-RELATED HAZARD INFORMATION FROM SAR

Lecture 4: Cal/Val Results of Flood Extent Algorithm

COMPARISON NEAR-SIMULTANEOUS OPTICAL IMAGERY – MISSOURI RIVER, NEBRASKA

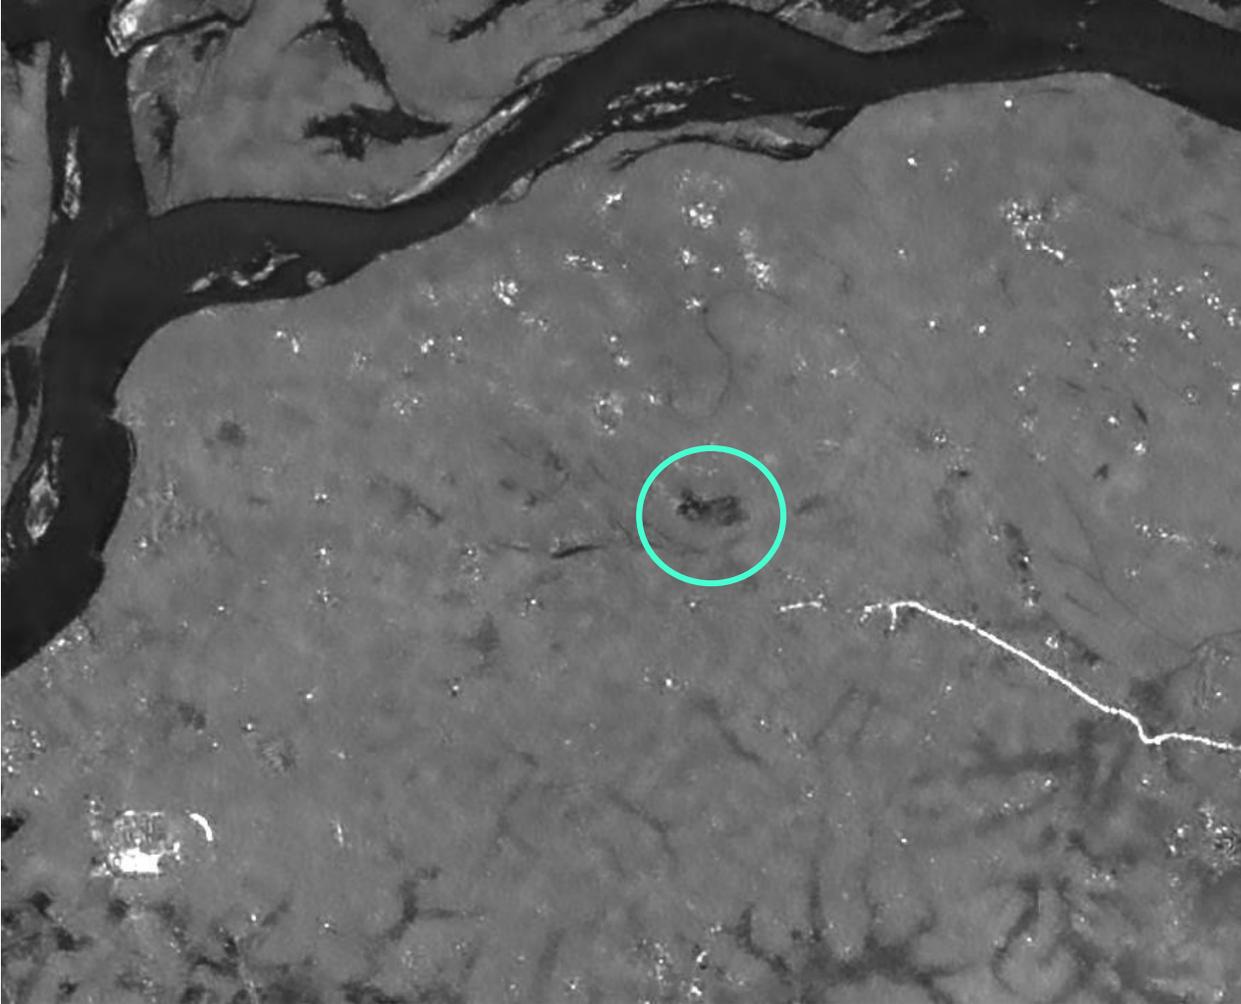
VW Amplitude image – 12 June 2020
